SITE: Any Street

CCTV Survey Report

Sewer Inspection, Cleaning and Repair

| Project Name | Project Number | Project Date |
|---|---|---|
| Buildover sample survey | | 13/07/2023 |

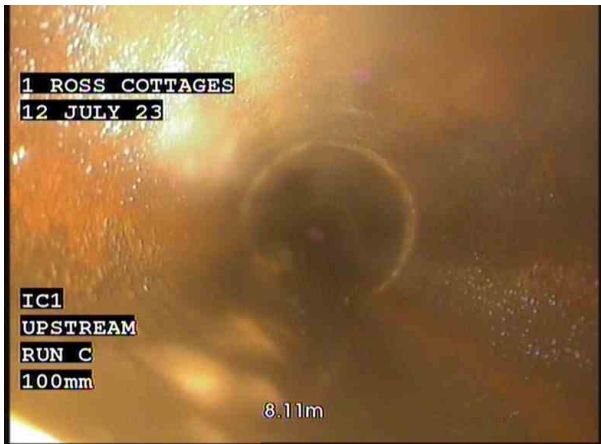
1, 00:00:33, 8.11 m
Settled deposits, other, 10% cross-sectional area loss, Debris

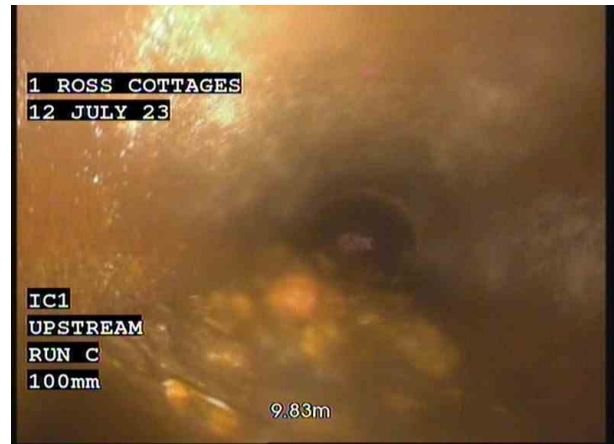
| Section | PLR | Grade | Description |
|---|---|---|---|
| 1 | IC2X | 4 | Settled deposits, other, 25% cross-sectional area loss, finish |

2, 00:00:40, 9.83 m
Settled deposits, other, 25% cross-sectional area loss, start, Stones

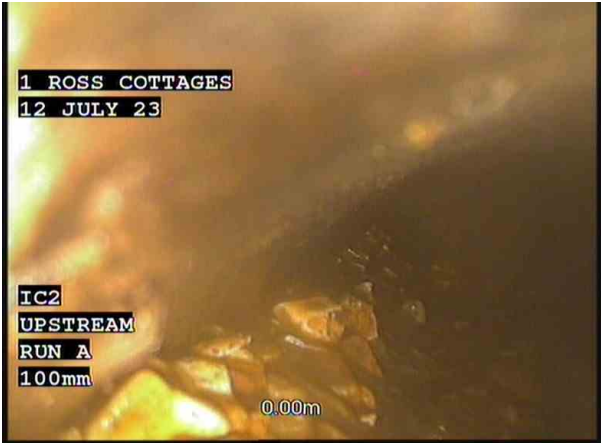
<table><tr> <td style="width: 15%;">0.00</td> <td style="width: 5%;">MH</td> <td style="width: 45%;">Start node, manhole, reference: IC2</td> <td style="width: 35%;"></td> </tr><tr> <td>0.10</td> <td>S01</td> <td>DES Settled deposits, fine, 20% cross-sectional area loss, start: Stones</td> <td>4</td> </tr></table>

1, 00:00:01, 0.10 m
Settled deposits, fine, 20% cross-sectional area loss, start,
Stones

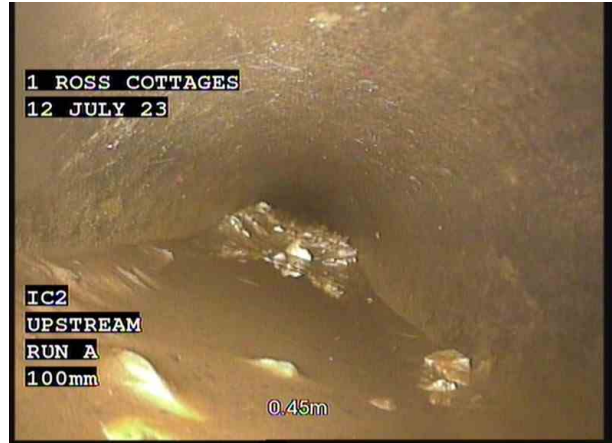
<table><tr> <td style="width: 15%;">0.00</td> <td style="width: 5%;">MH</td> <td style="width: 45%;">Start node, manhole, reference: IC2</td> <td style="width: 35%;"></td> </tr><tr> <td>0.45</td> <td>S02</td> <td>DES Settled deposits, fine, 20% cross-sectional area loss, start</td> <td>4</td> </tr></table>

2, 00:00:29, 0.45 m
Settled deposits, fine, 20% cross-sectional area loss, start

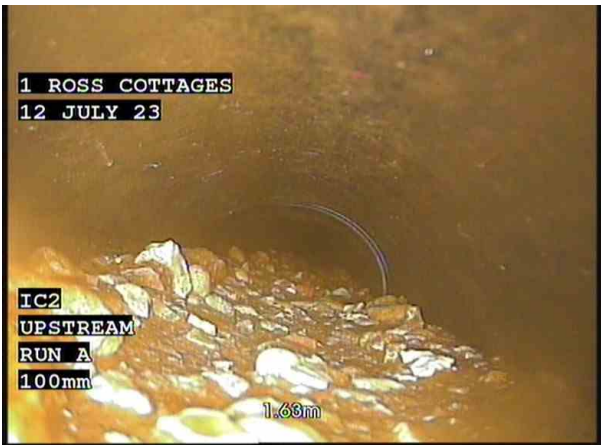
<table><tr> <td style="width: 15%;">0.00</td> <td style="width: 5%;">MH</td> <td style="width: 45%;">Start node, manhole, reference: IC2</td> <td style="width: 35%;"></td> </tr><tr> <td>1.63</td> <td>SA</td> <td>Survey abandoned: Unable to continue</td> <td></td> </tr></table>

3, 00:00:52, 1.63 m
Survey abandoned, Unable to continue

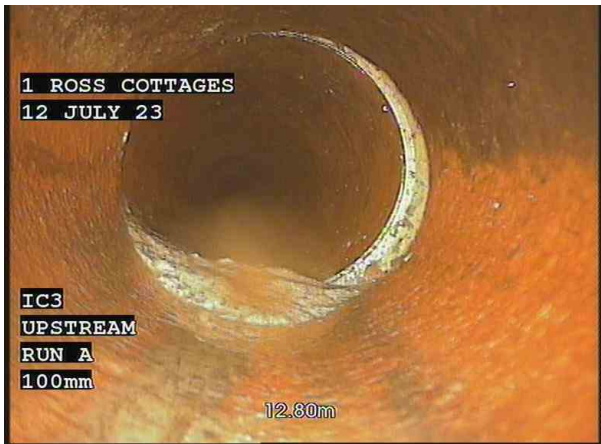
| Section | PLR | Grade | Description |
|---|---|---|---|
| 4 | IC4X | 3 | Settled deposits, hard or compacted at joint, 10% cross-sectional area loss |

1, 00:01:06, 12.80 m
Settled deposits, hard or compacted at joint, 10% cross-sectional area loss, Scale
