*Project ref: TV-----*

*30<sup>th</sup> March 2023*

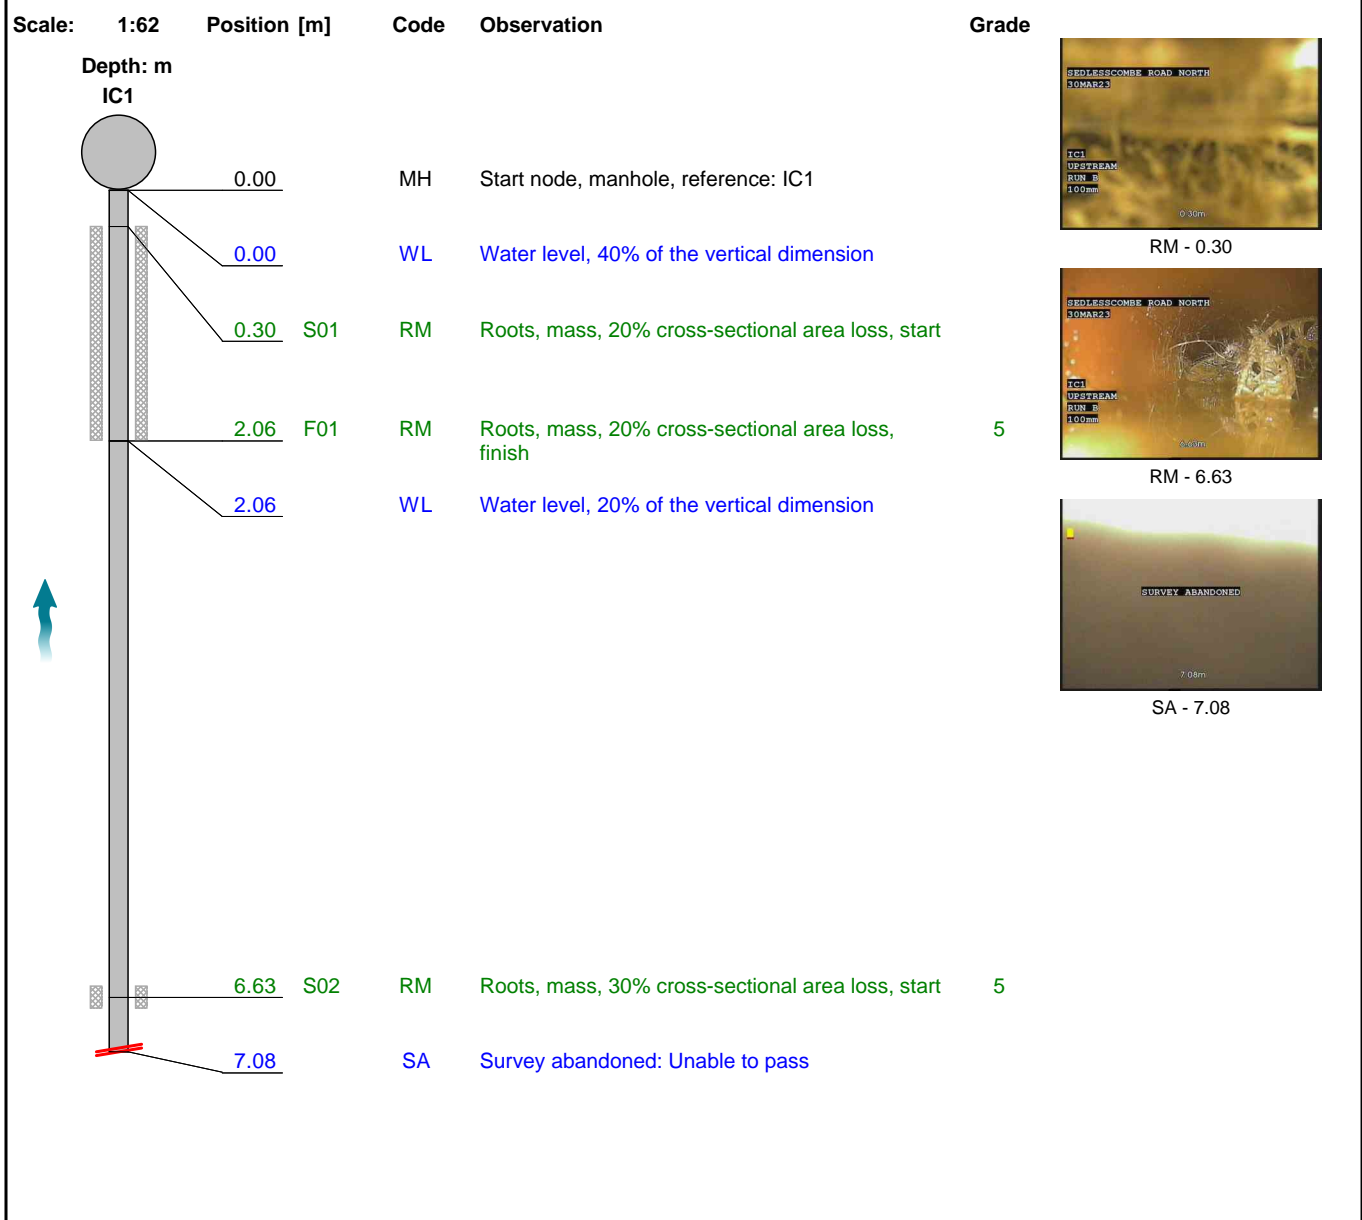
Construction Features					Miscellaneous Features				
Structural Defects					Service & Operational Observations				
STR No. Def	STR Peak	STR Mean	STR Total	STR Grade	SER No. Def	SER Peak	SER Mean	SER Total	SER Grade
0	0.0	0.0	0.0	1.0	2	10.0	4.2	30.0	5.0

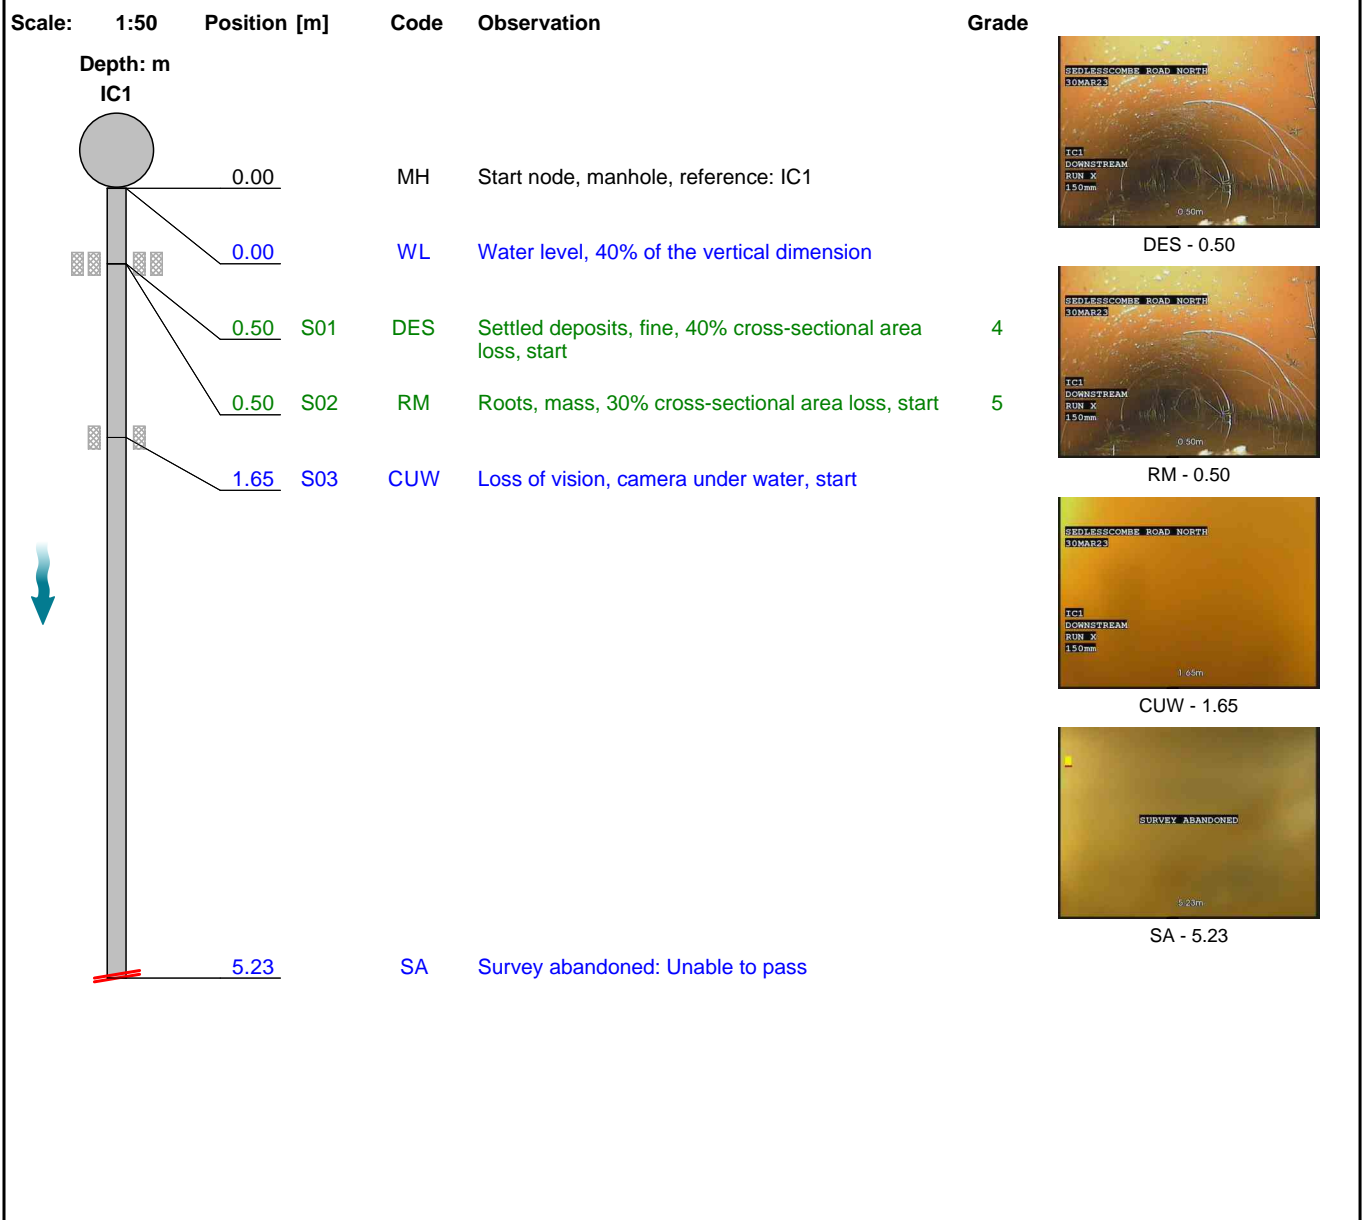
Construction Features					Miscellaneous Features				
Structural Defects					Service & Operational Observations				
STR No. Def	STR Peak	STR Mean	STR Total	STR Grade	SER No. Def	SER Peak	SER Mean	SER Total	SER Grade
0	0.0	0.0	0.0	1.0	2	0.0	2.9	15.0	4.0

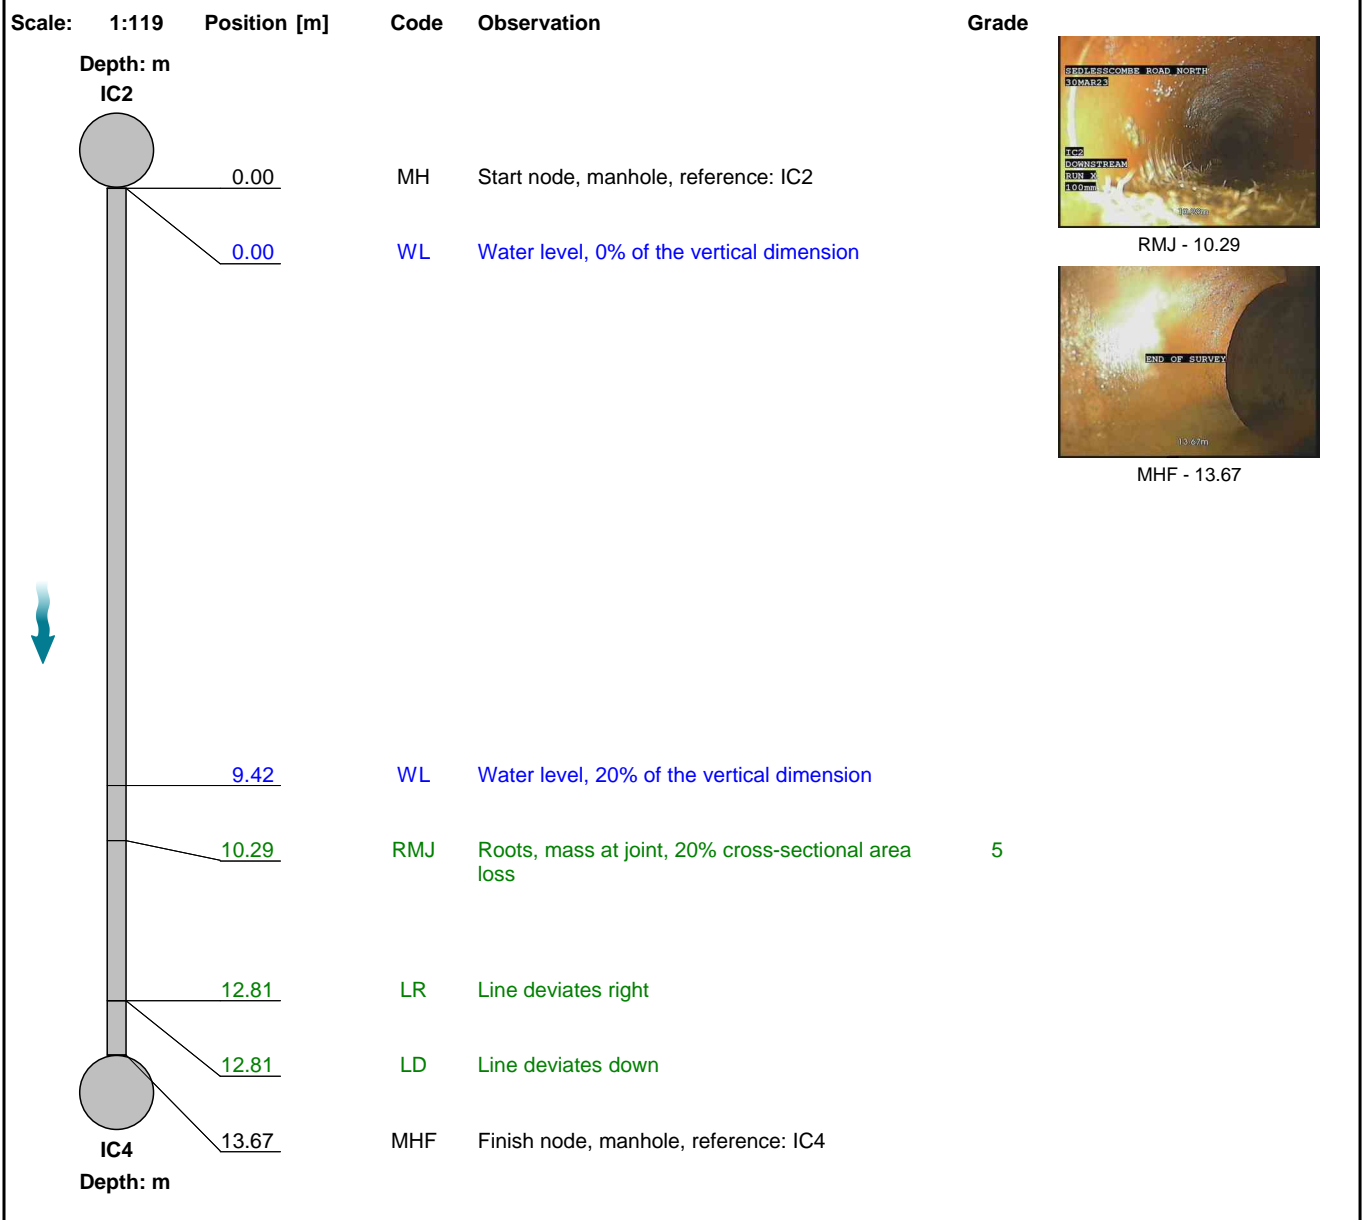
Construction Features					Miscellaneous Features				
Structural Defects					Service & Operational Observations				
STR No. Def	STR Peak	STR Mean	STR Total	STR Grade	SER No. Def	SER Peak	SER Mean	SER Total	SER Grade
0	0.0	0.0	0.0	1.0	1	10.0	0.7	10.0	5.0

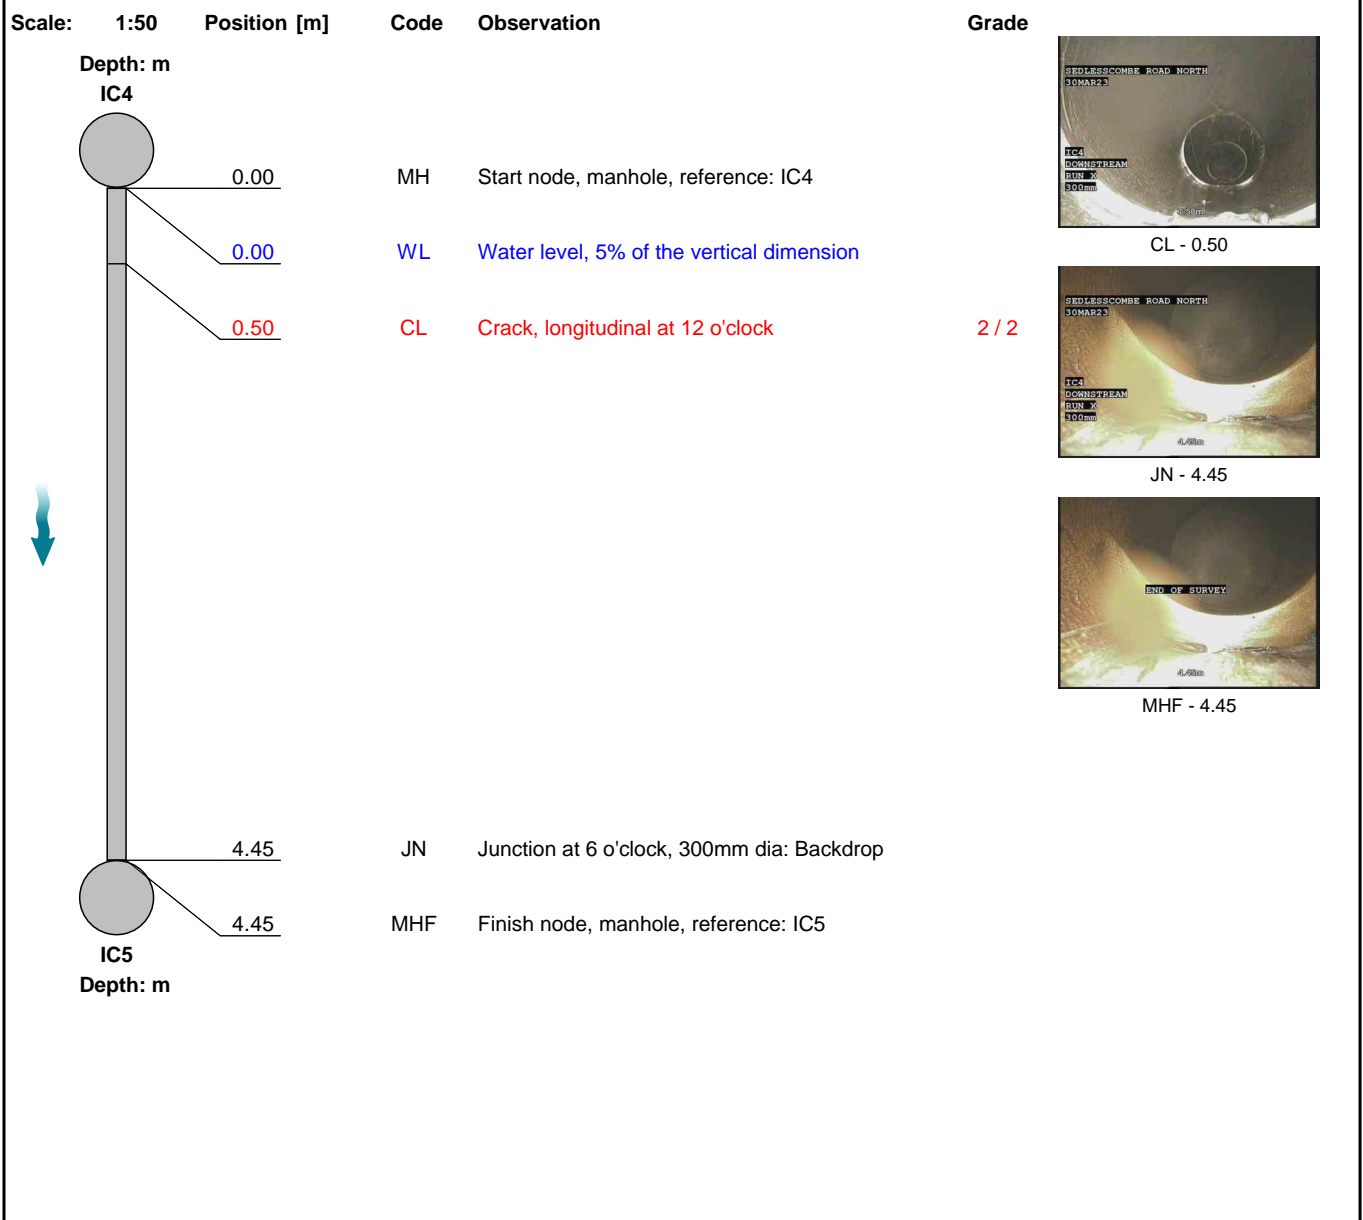
Construction Features					Miscellaneous Features				
Structural Defects					Service & Operational Observations				
STR No. Def	STR Peak	STR Mean	STR Total	STR Grade	SER No. Def	SER Peak	SER Mean	SER Total	SER Grade
1	10.0	2.2	10.0	2.0	1	1.0	0.2	1.0	2.0

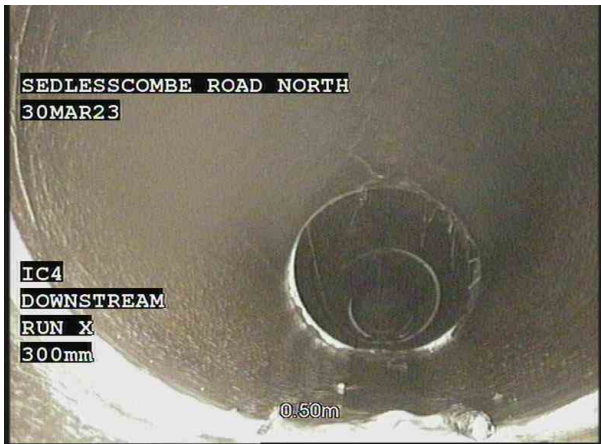
1, 00:00:10, 0.50 m  
Crack, longitudinal at 12 o'clock

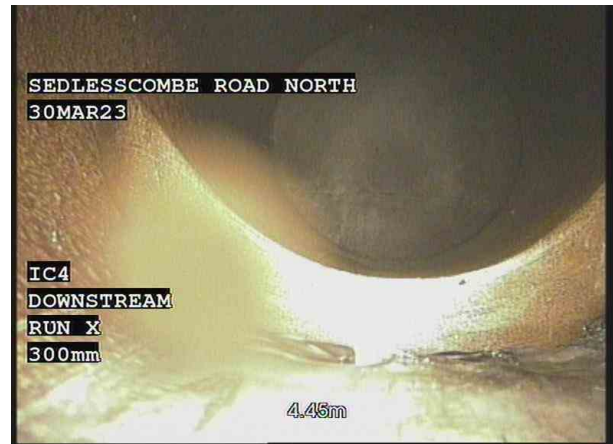
2, 00:00:46, 4.45 m  
Junction at 6 o'clock, 300mm dia, Backdrop

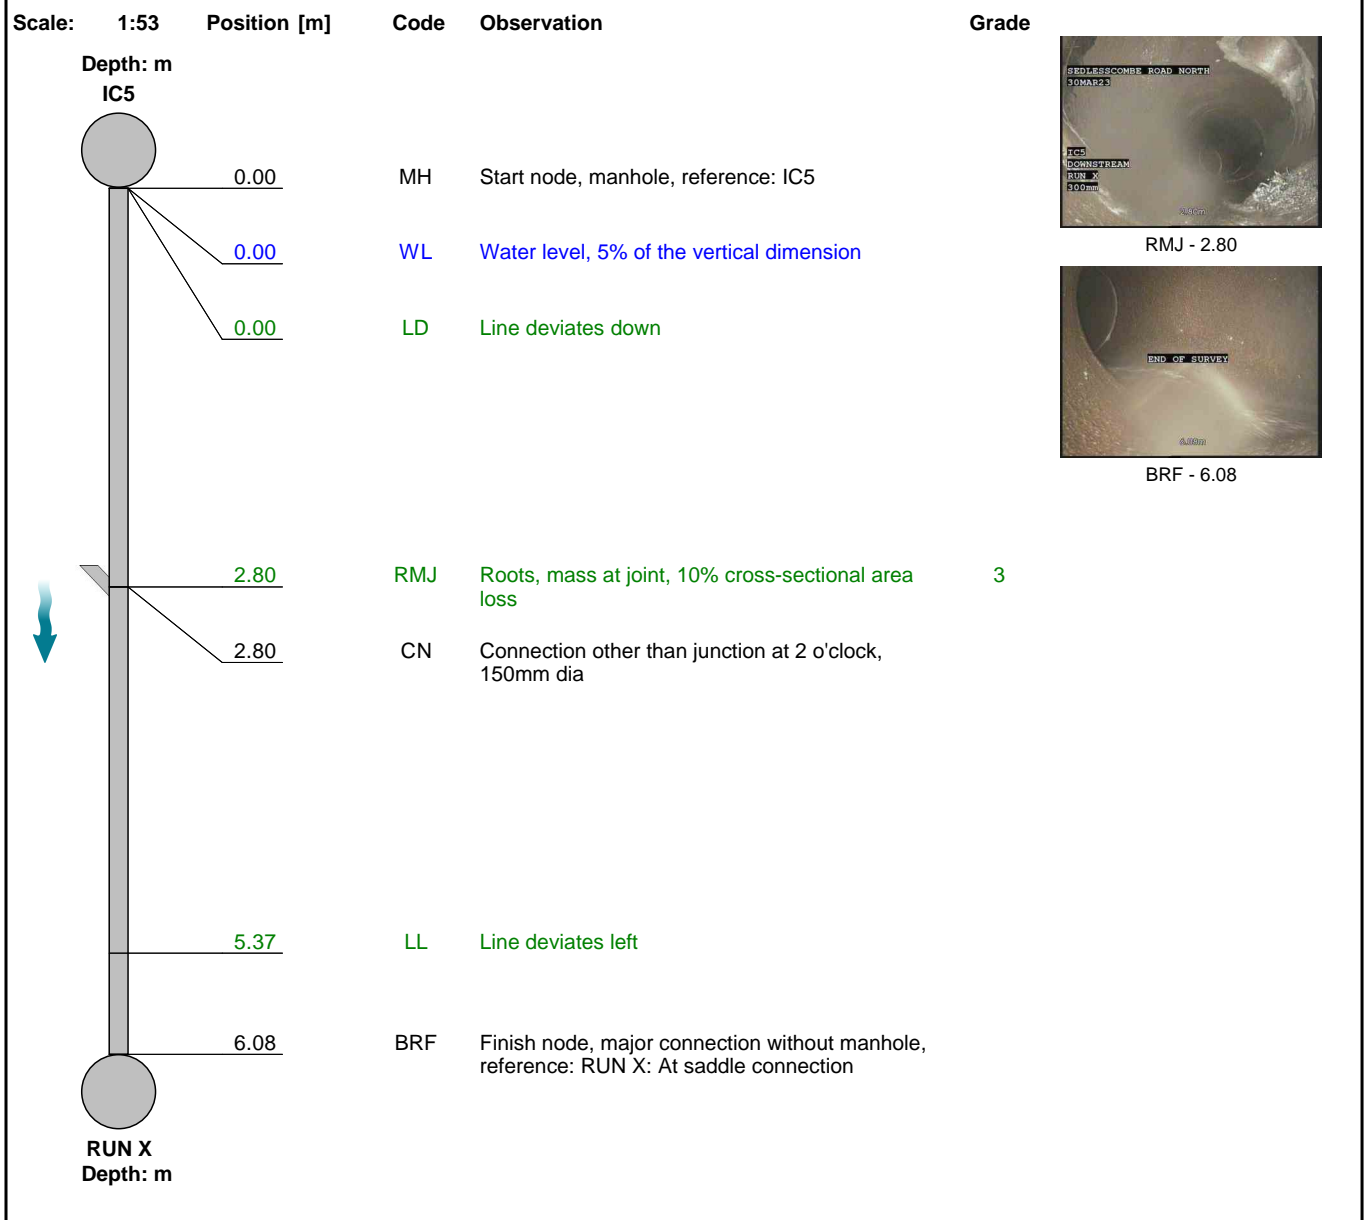
Construction Features					Miscellaneous Features				
Structural Defects					Service & Operational Observations				
STR No. Def	STR Peak	STR Mean	STR Total	STR Grade	SER No. Def	SER Peak	SER Mean	SER Total	SER Grade
0	0.0	0.0	0.0	1.0	1	4.0	0.7	4.0	3.0

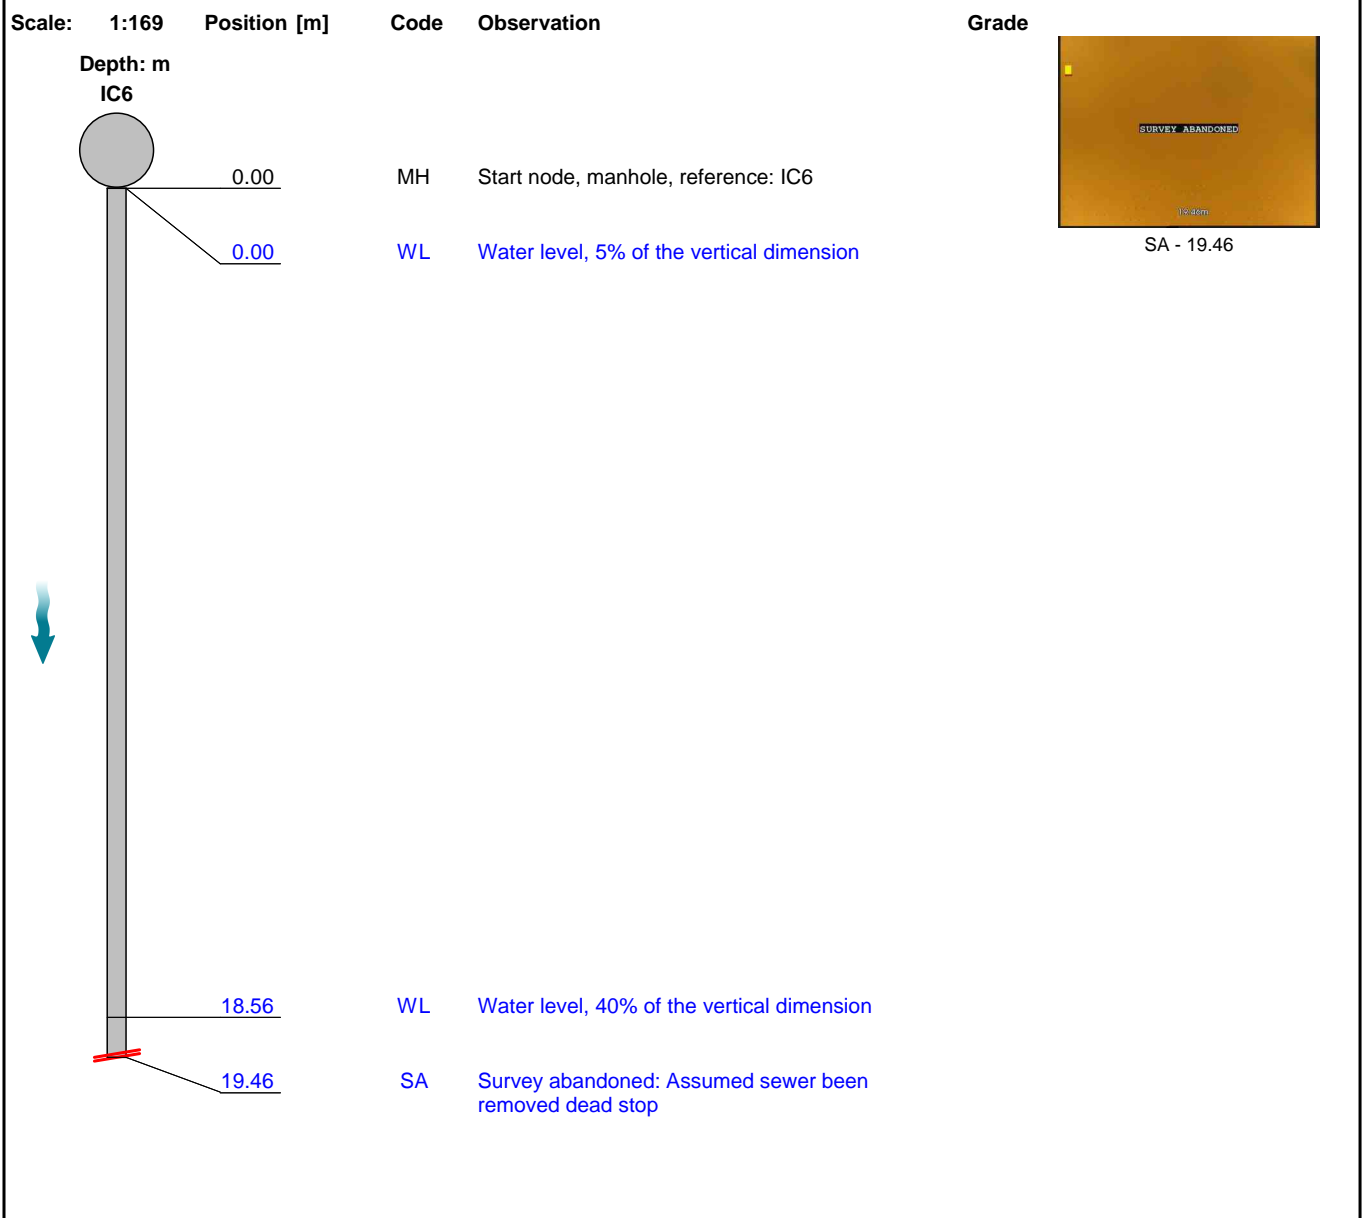
Construction Features					Miscellaneous Features				
Structural Defects					Service & Operational Observations				
STR No. Def	STR Peak	STR Mean	STR Total	STR Grade	SER No. Def	SER Peak	SER Mean	SER Total	SER Grade
0	0.0	0.0	0.0	1.0	0	0.0	0.0	0.0	1.0

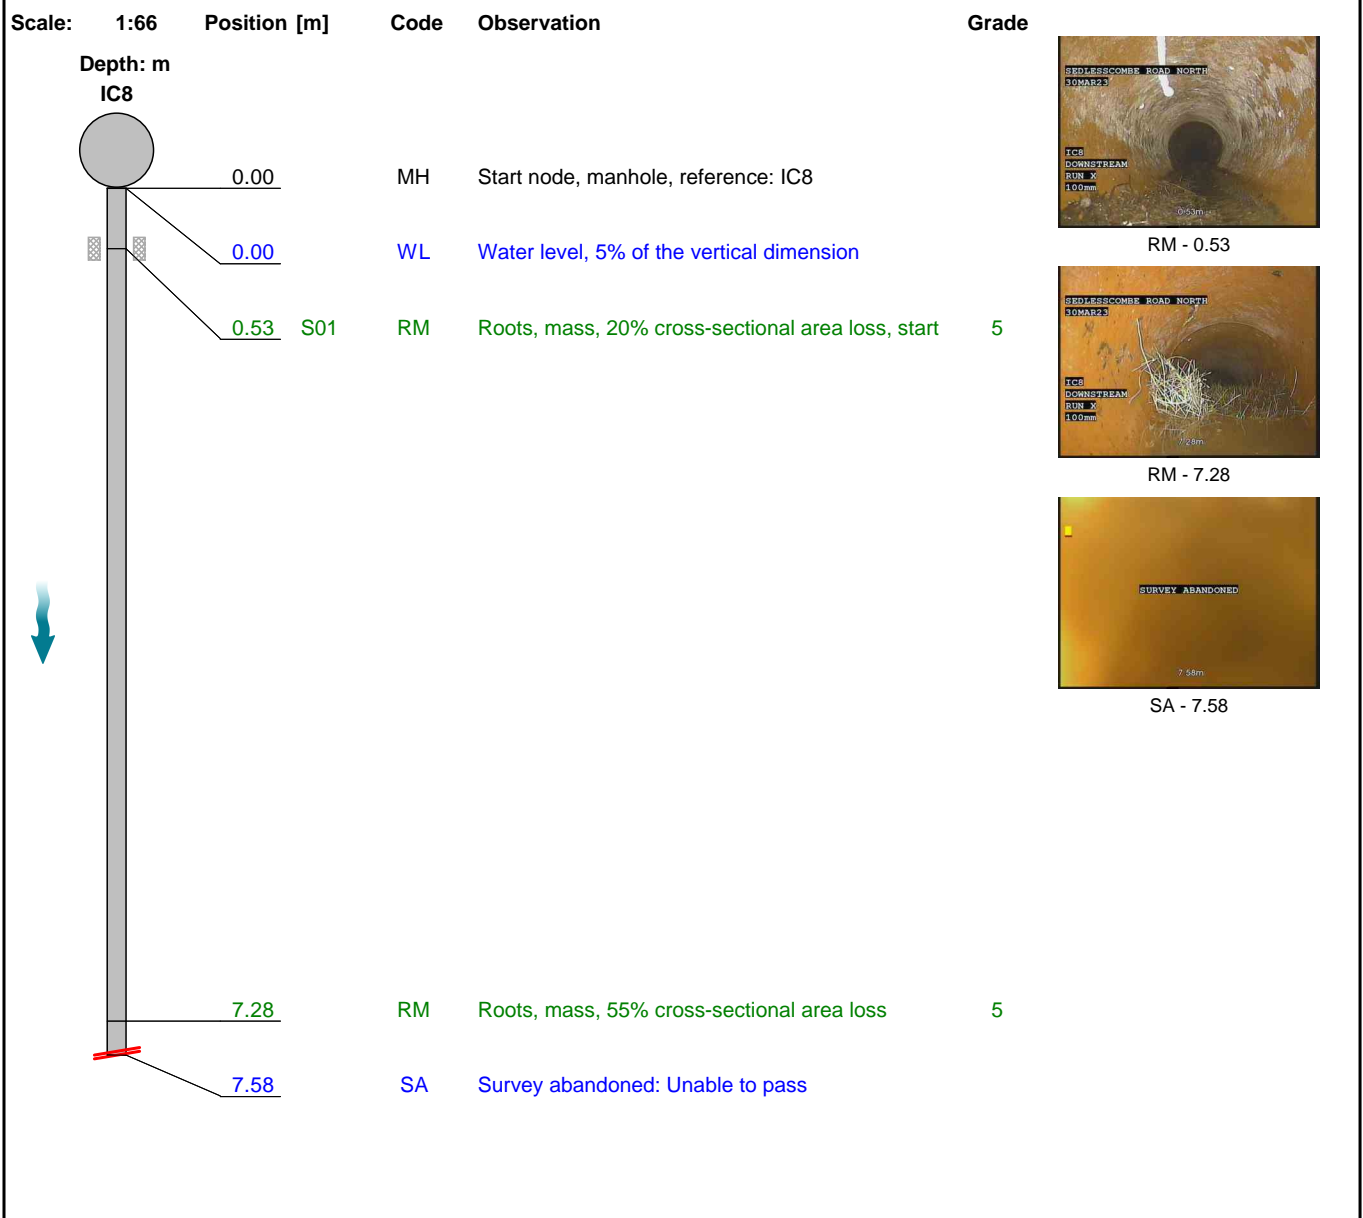
Construction Features					Miscellaneous Features				
Structural Defects					Service & Operational Observations				
STR No. Def	STR Peak	STR Mean	STR Total	STR Grade	SER No. Def	SER Peak	SER Mean	SER Total	SER Grade
0	0.0	0.0	0.0	1.0	2	15.0	3.3	25.0	5.0

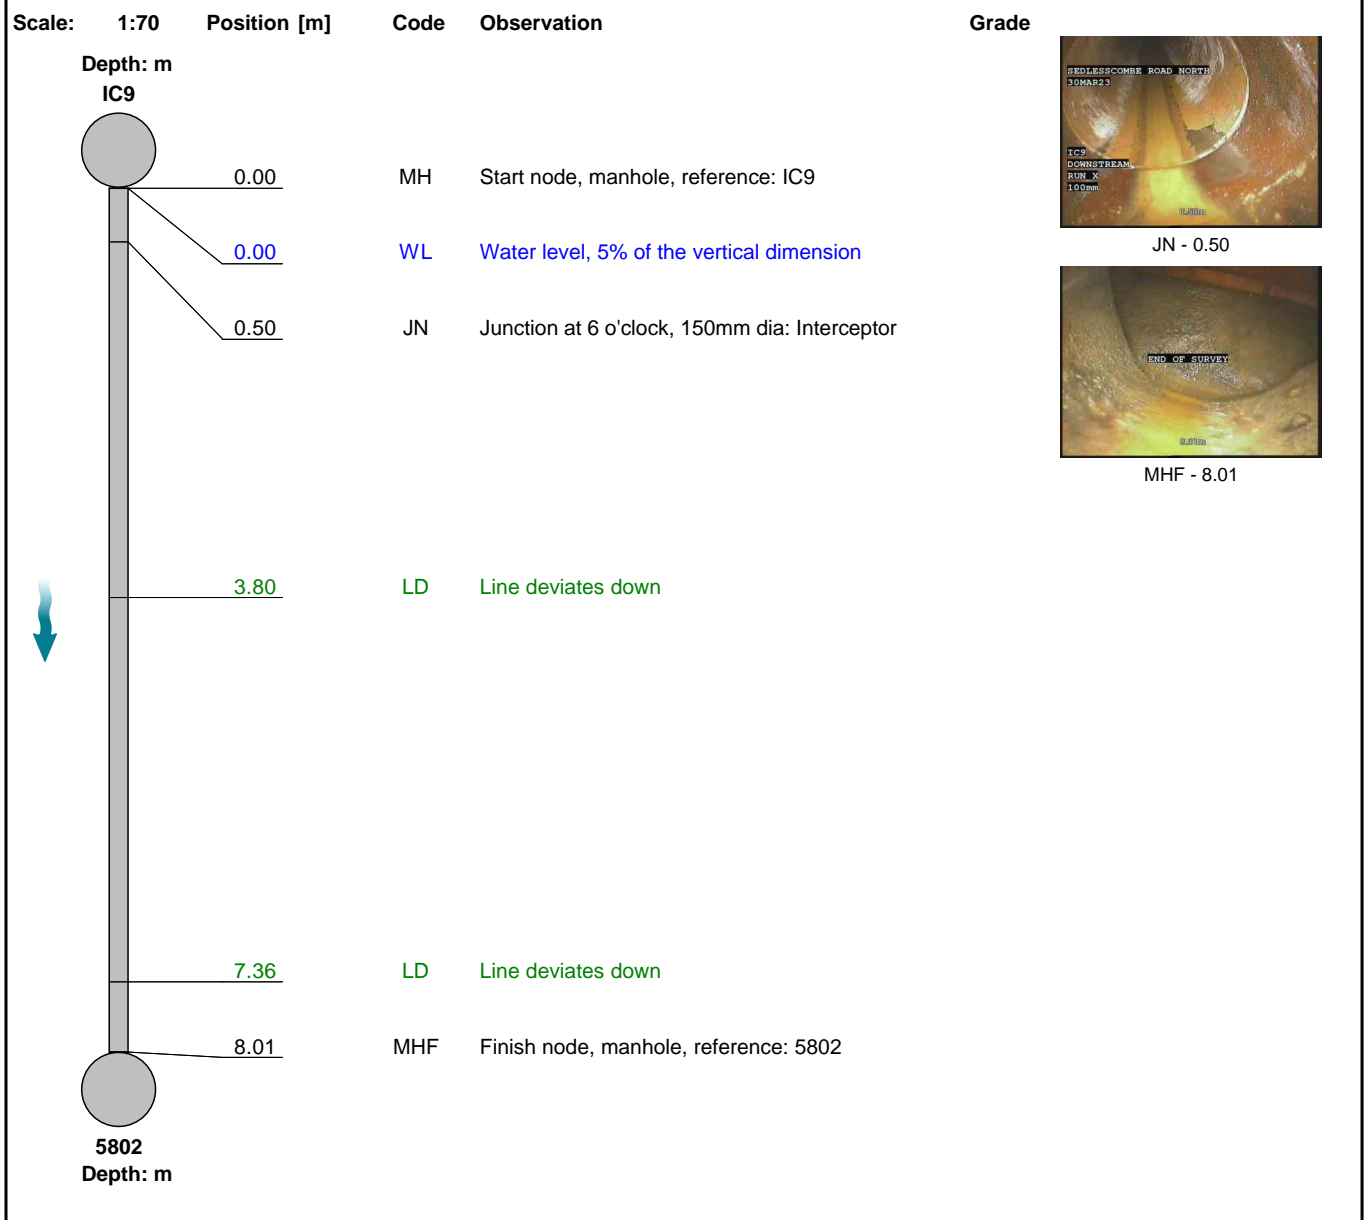
Construction Features					Miscellaneous Features				
Structural Defects					Service & Operational Observations				
STR No. Def	STR Peak	STR Mean	STR Total	STR Grade	SER No. Def	SER Peak	SER Mean	SER Total	SER Grade
0	0.0	0.0	0.0	1.0	0	0.0	0.0	0.0	1.0

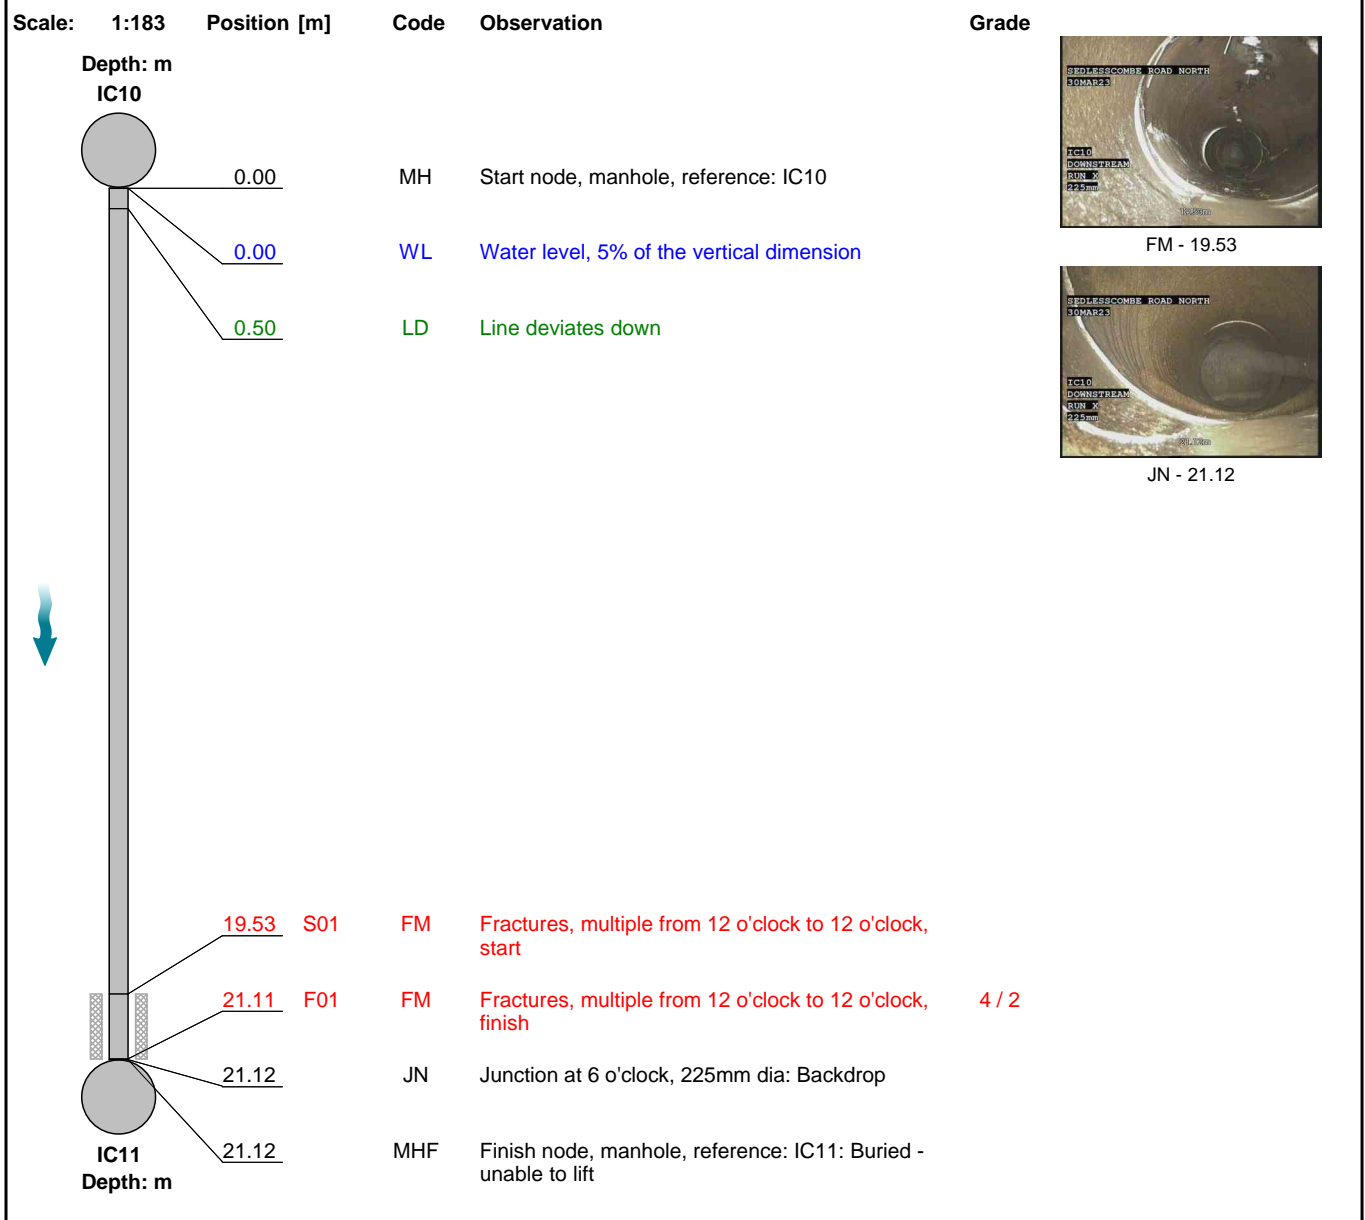
Construction Features					Miscellaneous Features				
Structural Defects					Service & Operational Observations				
STR No. Def	STR Peak	STR Mean	STR Total	STR Grade	SER No. Def	SER Peak	SER Mean	SER Total	SER Grade
1	80.0	7.6	160.0	4.0	1	1.0	0.1	2.0	2.0

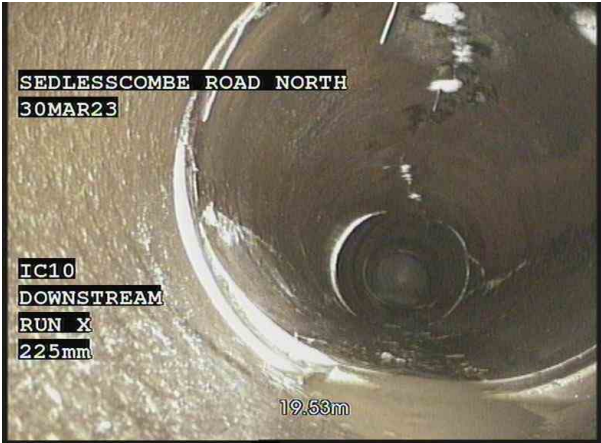
1, 00:01:16, 19.53 m  
Fractures, multiple from 12 o'clock to 12 o'clock, start

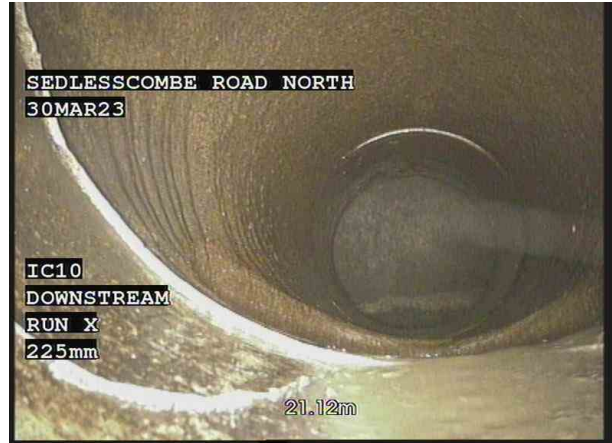
2, 00:01:56, 21.12 m  
Junction at 6 o'clock, 225mm dia, Backdrop

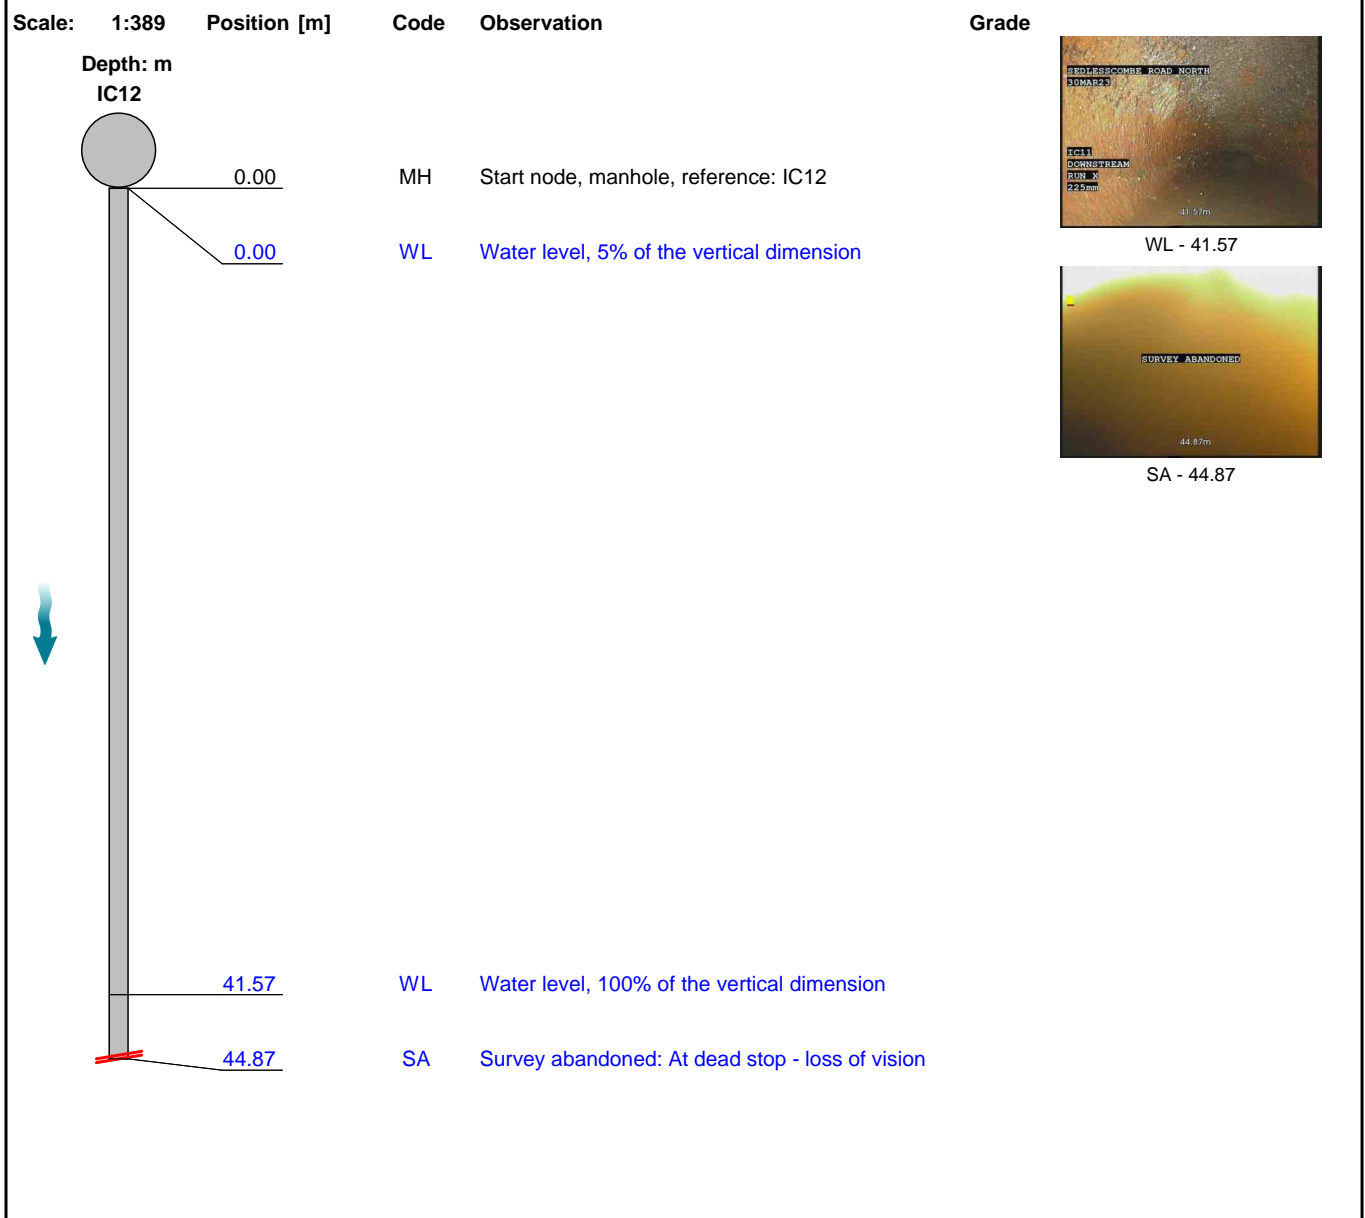
Construction Features					Miscellaneous Features				
Structural Defects					Service & Operational Observations				
STR No. Def	STR Peak	STR Mean	STR Total	STR Grade	SER No. Def	SER Peak	SER Mean	SER Total	SER Grade
0	0.0	0.0	0.0	1.0	0	0.0	0.0	0.0	1.0

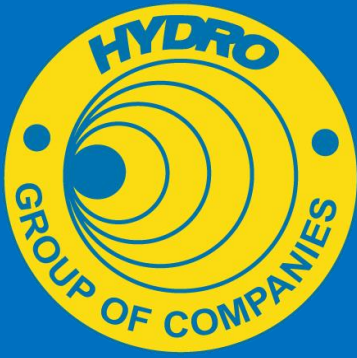
2, 00:02:41, 44.87 m  
Survey abandoned, At dead stop - loss of vision

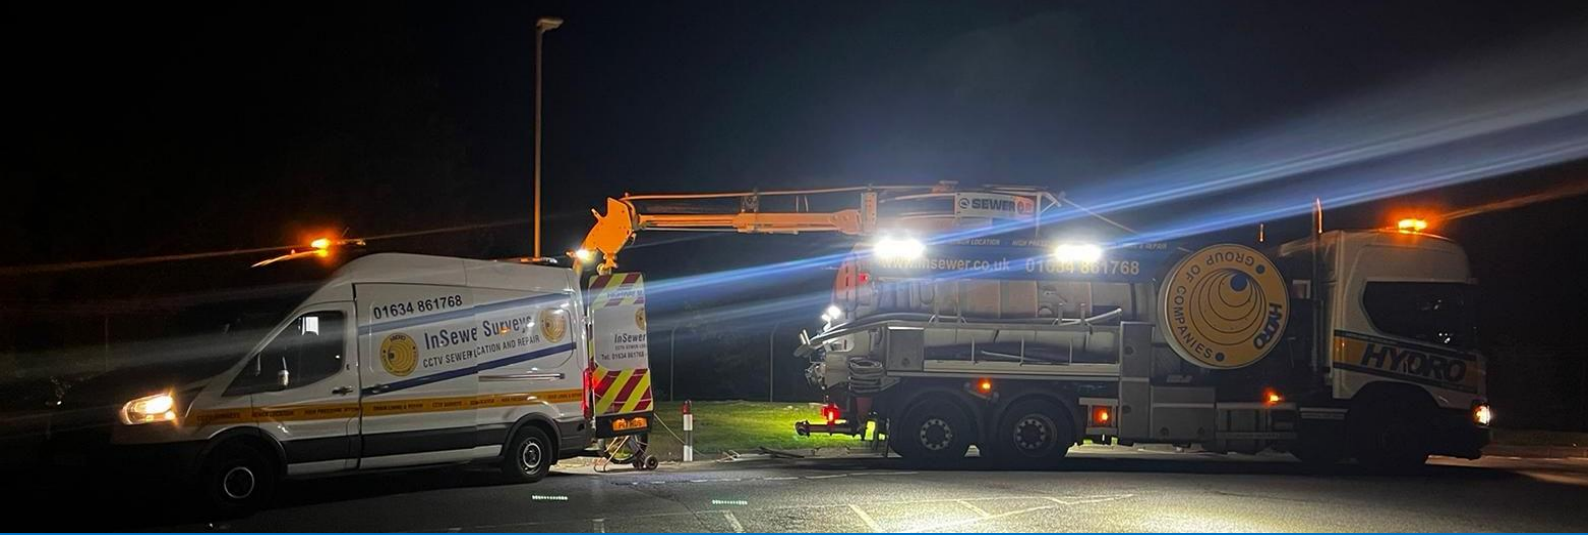
***"A Family Run Business since 1977"***
